STRUCTURAL ASSESSMENT REPORT

DATE: April 21, 2017
(Revised April 25, 2017)

PROJECT: Ronald Reagan Building – 14th Street ramps
Investigation of Ceiling Failure at the 14th Street North Vehicle Ramp

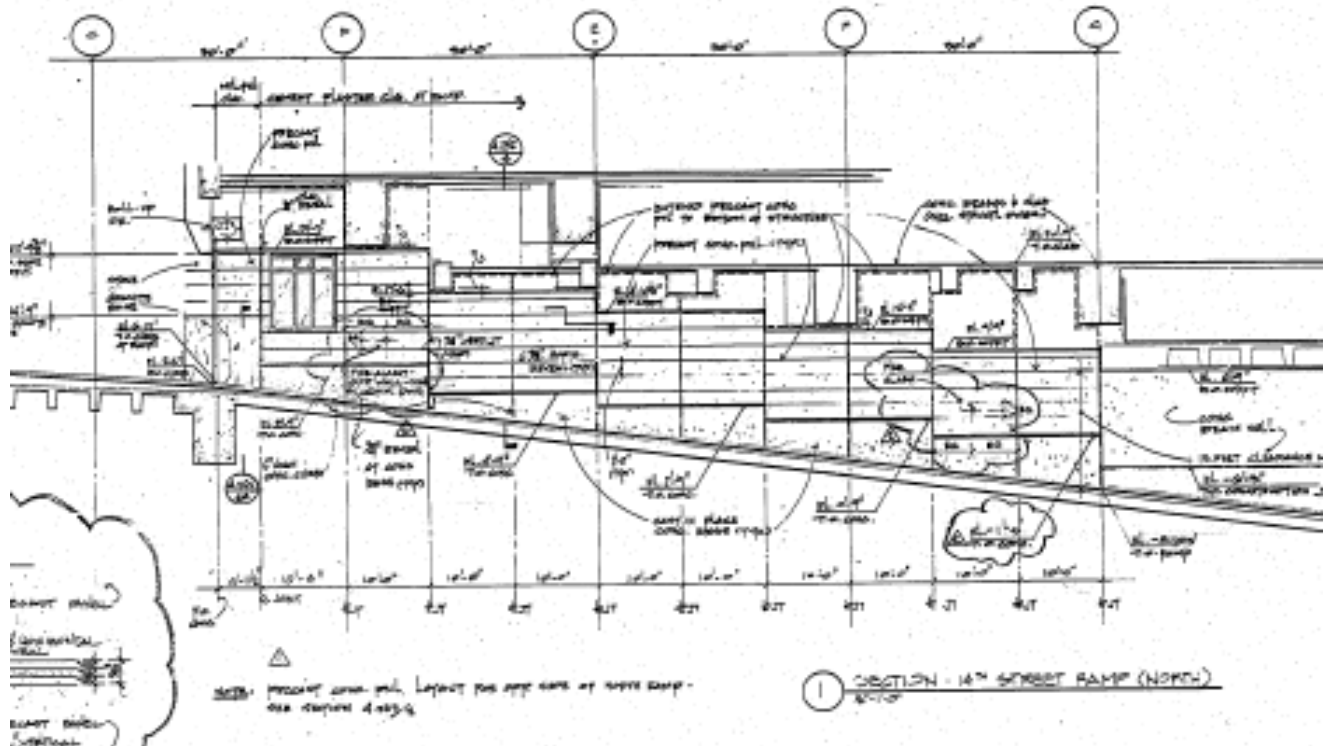
Figure 1: 14th Street North Ramp Section

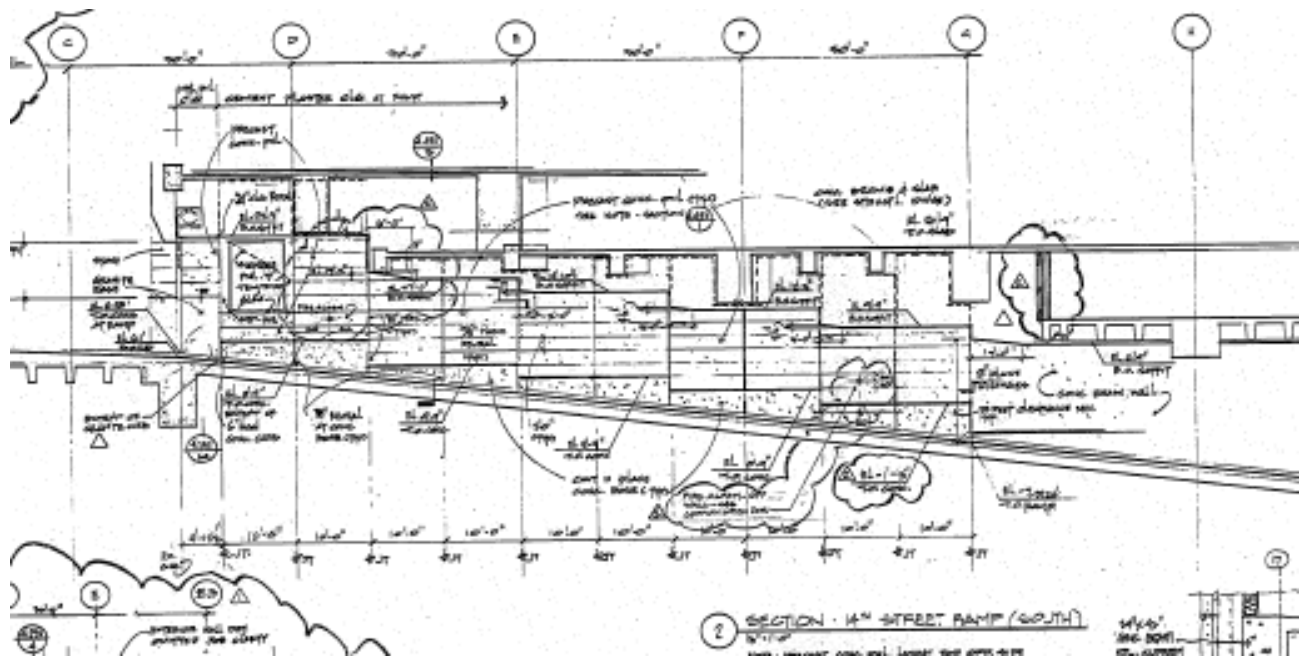
Figure 2: 14th Street South Ramp Section

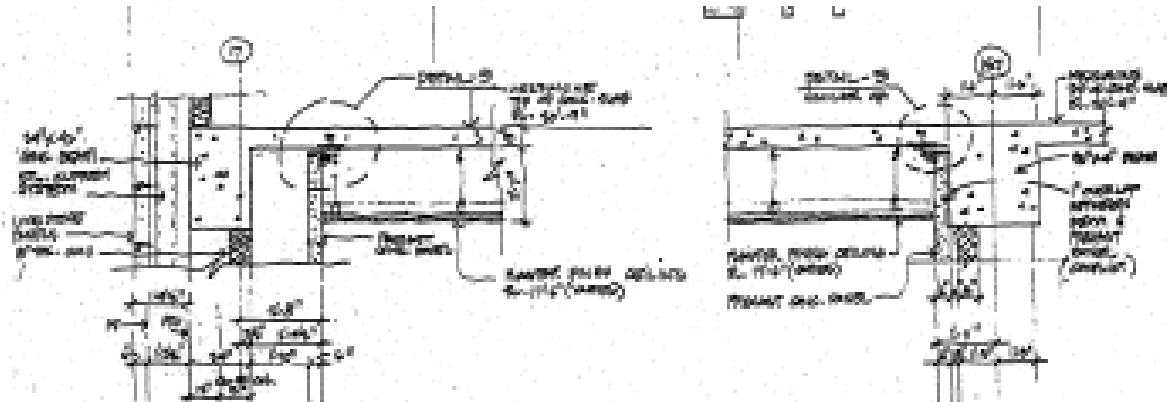
Existing building drawings do not provide ceiling support details even though wire hangers seem to have been shown. Specifications for the plaster ceilings were not available at this time. Shop drawings for the plaster ceilings, hangers and framing were also not available at this time.

Figure 3: Section showing wire hangers

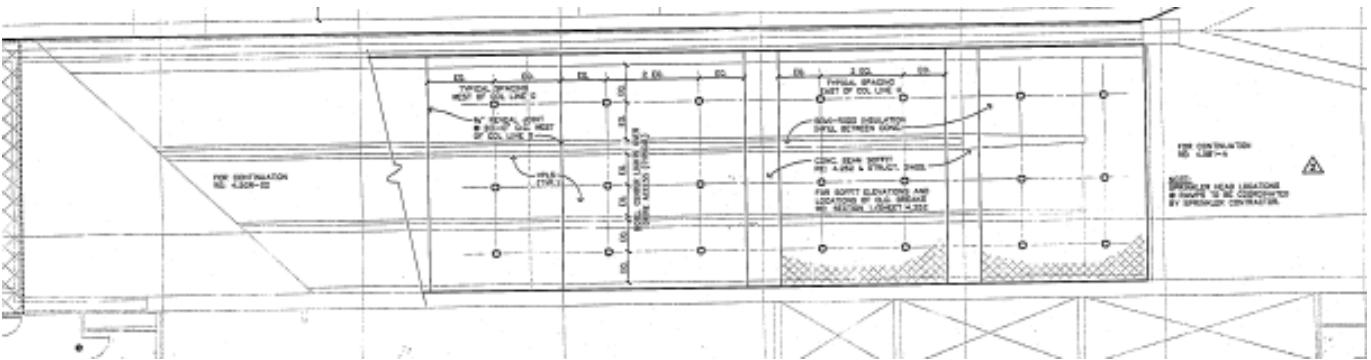
Figure 4: 14th Street North Ramp Reflected Ceiling Plan – B1 Level

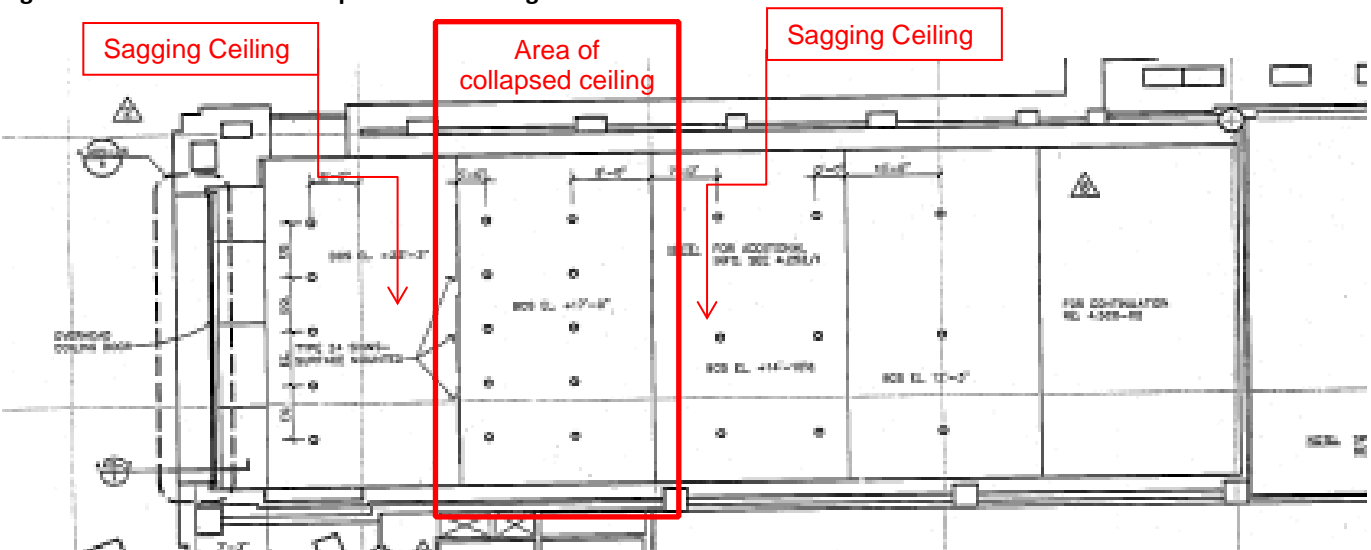
Figure 5: 14th Street North Ramp Reflected Ceiling Plan – Concourse Level

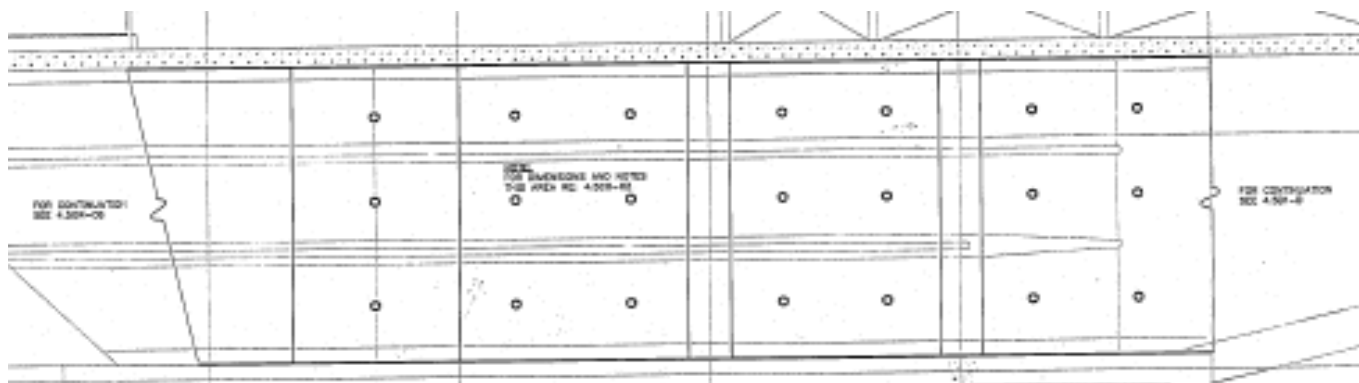
Figure 6: 14th Street South Ramp Reflected Ceiling Plan – B1 Level

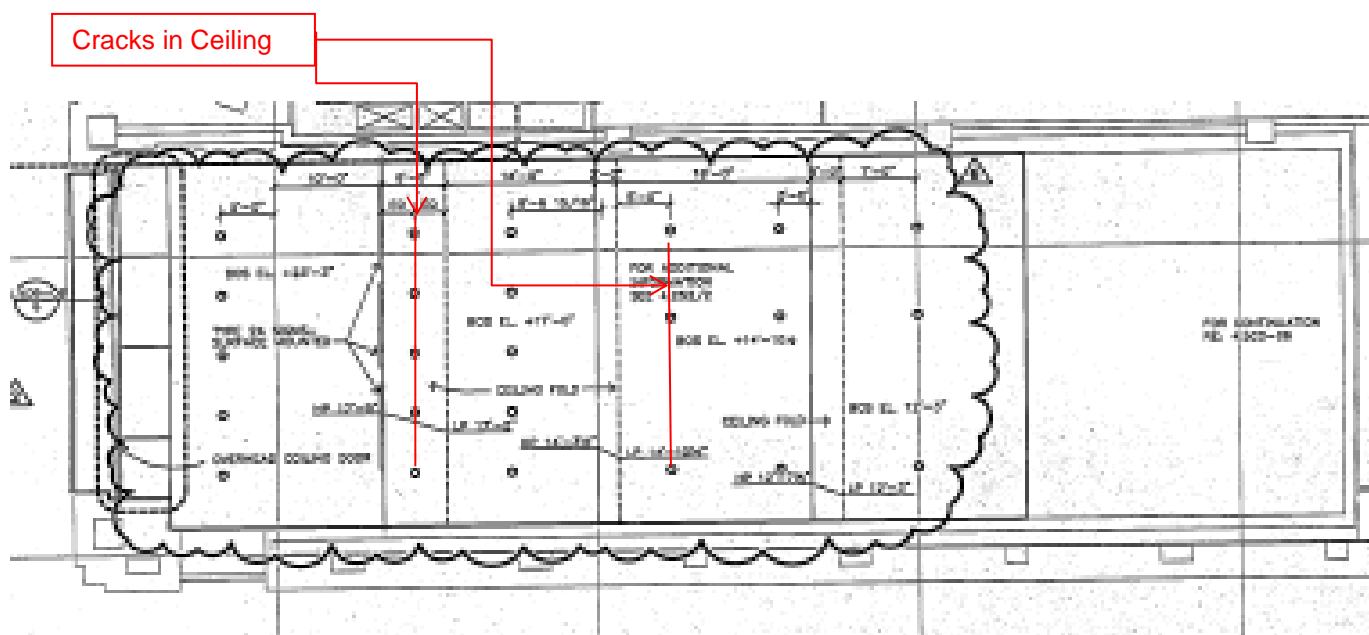
Figure 7: 14th Street South Ramp Reflected Ceiling Plan – Concourse Level (Daily monitoring Required)

- 3) Immediately set up a daily monitoring protocol for the south ramp with twice daily close inspection of the ceilings by the building engineers. OPDQ to be informed of any excessive cracks, sagging or any indication of deficiencies in the south ramp ceiling.

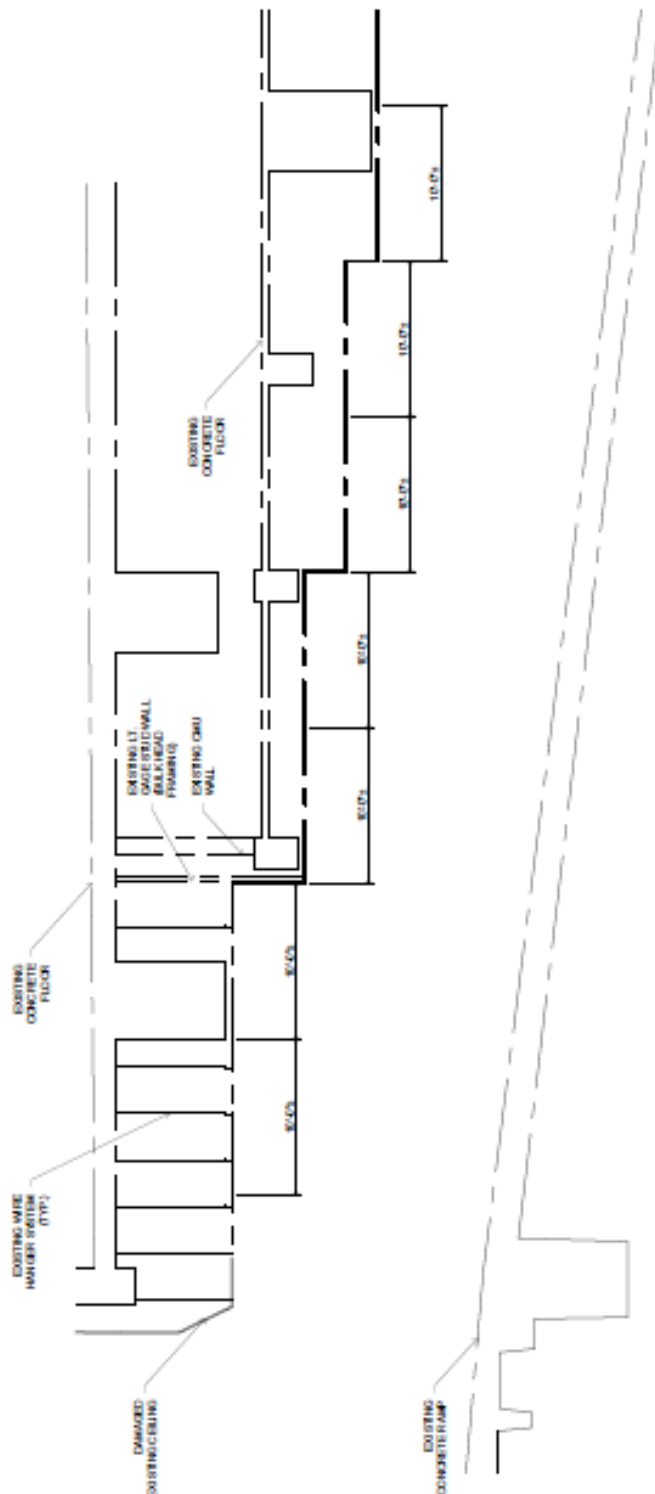
Figure 8: 14th Street South Ramp cross section – Sketch for Existing Conditions

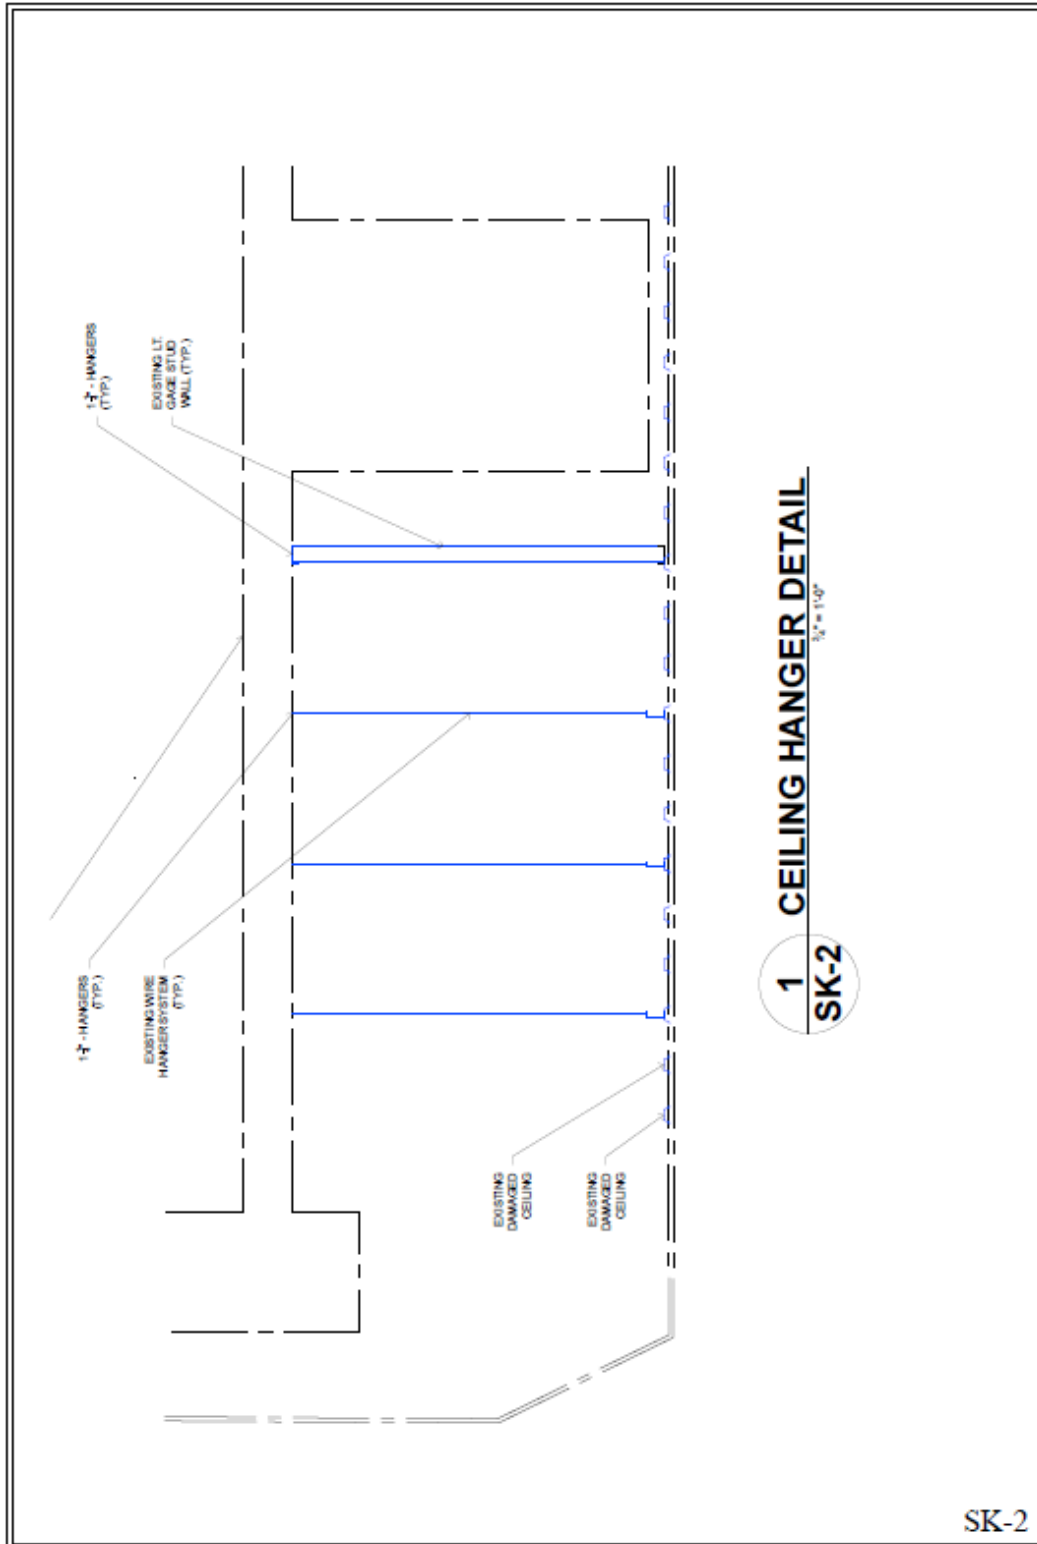
Figure 9: 14th Street South Ramp cross section – Sketch for Existing Conditions Details

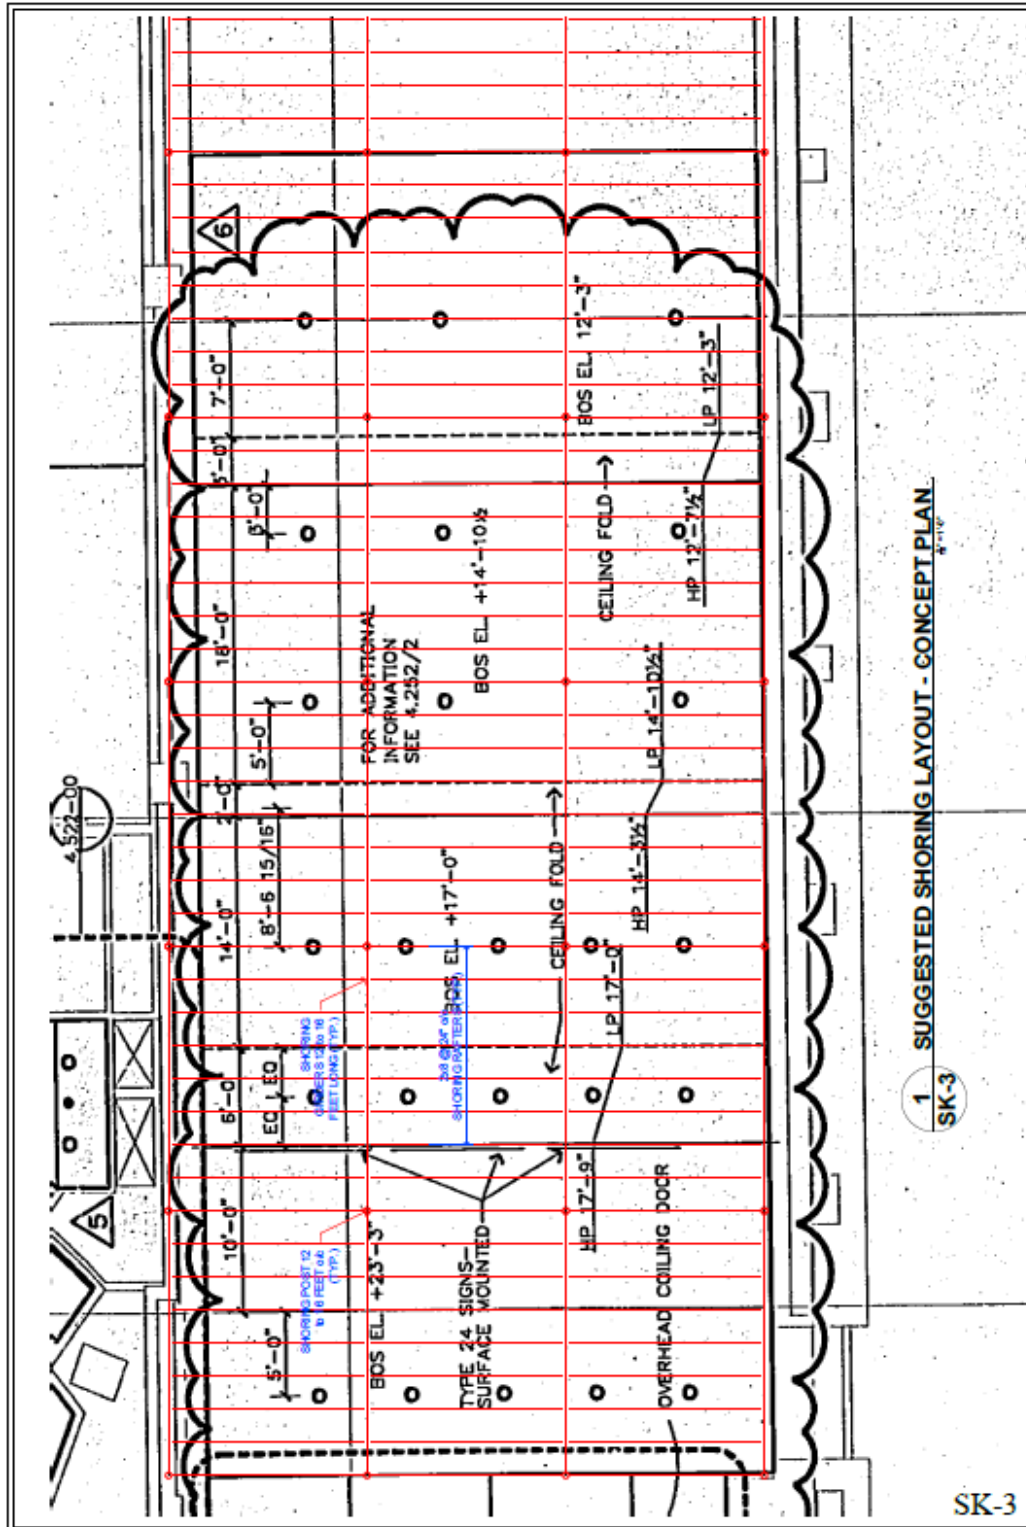
Figure 10: 14th Street North Ramp – Sketch for Shoring Suggested Concept Plan

- 4) Remove all ceiling or install temporary shoring under the 14th Street North and South Ramp until repairs are performed.
- 5) Immediately come up with a temporary shoring design performed by a registered structural engineer (if especially the strengthening option is selected) for the South ramp in order to keep it operational. Since the shoring is supporting ceiling only, a typical pedestrian walkway overhead protection may be used. This could be done by using 2x10 rafters spaced at 24" on center (not to exceed 14 feet in span) that get supported by girder beams placed parallel to the two concrete walls and along the two raised median concrete wall or concrete curb. The girder beams may be typical scaffolding beams supported by columns spaced at a 12 feet to 16 feet spacing. See attached sketches for shoring concept plans. Please note that OPDQ has suggested the attached temporary shoring layout for pricing purposes. A professional Structural engineer needs to design the shoring system.

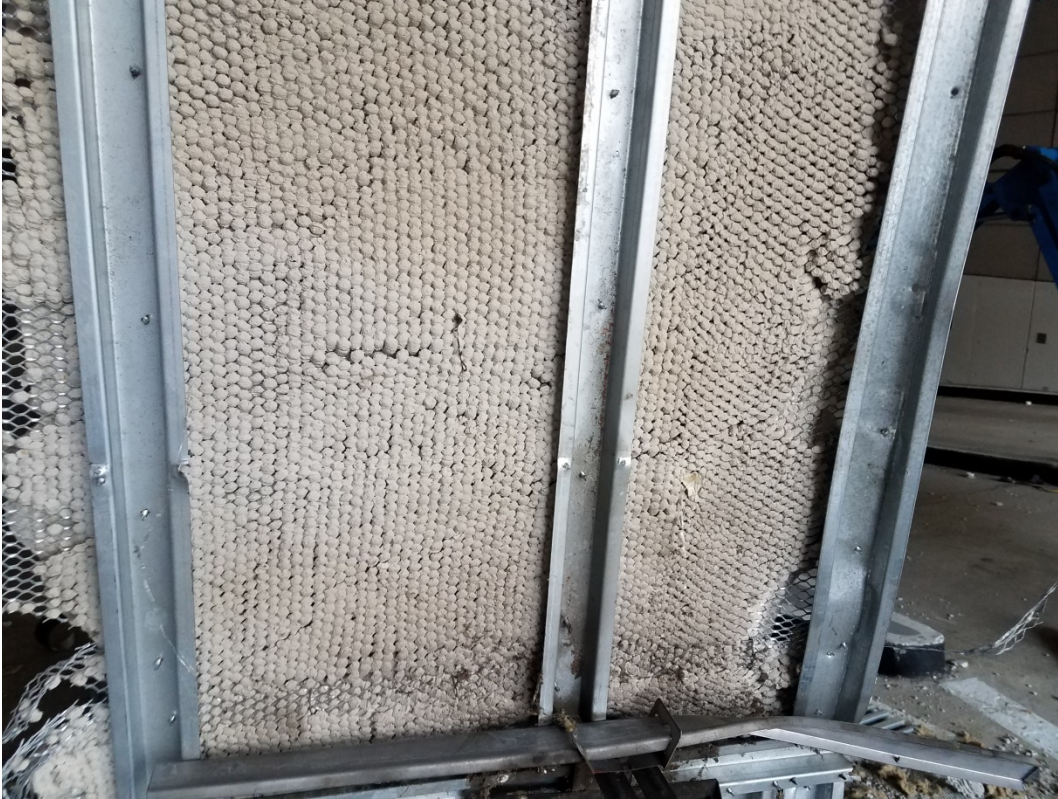
Picture 1: Typical Existing Framing – Plaster Ceiling construction (underside of the ceiling)

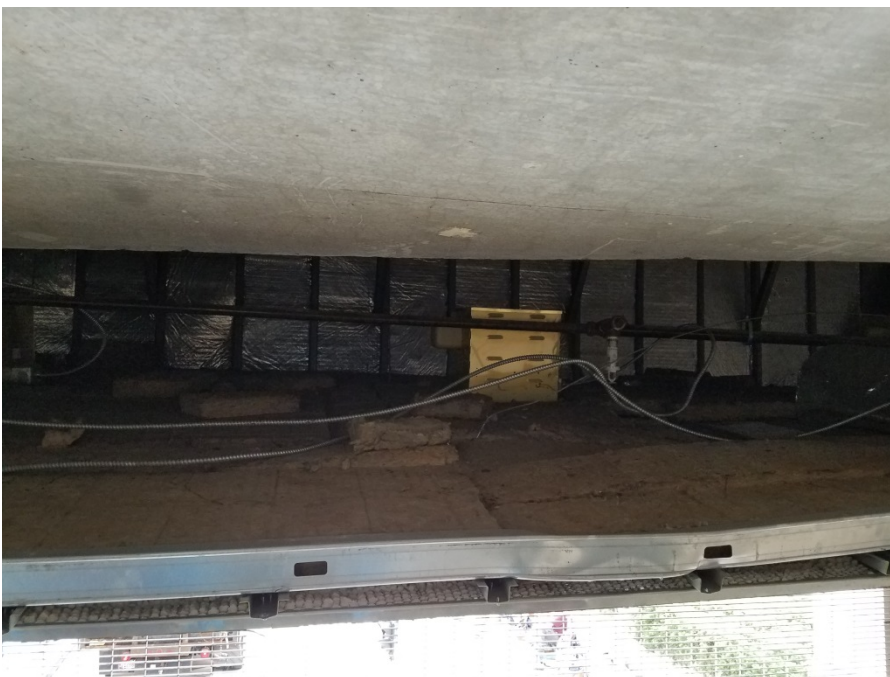
Picture 2: Typical existing framing – sagging ceiling at North Ramp

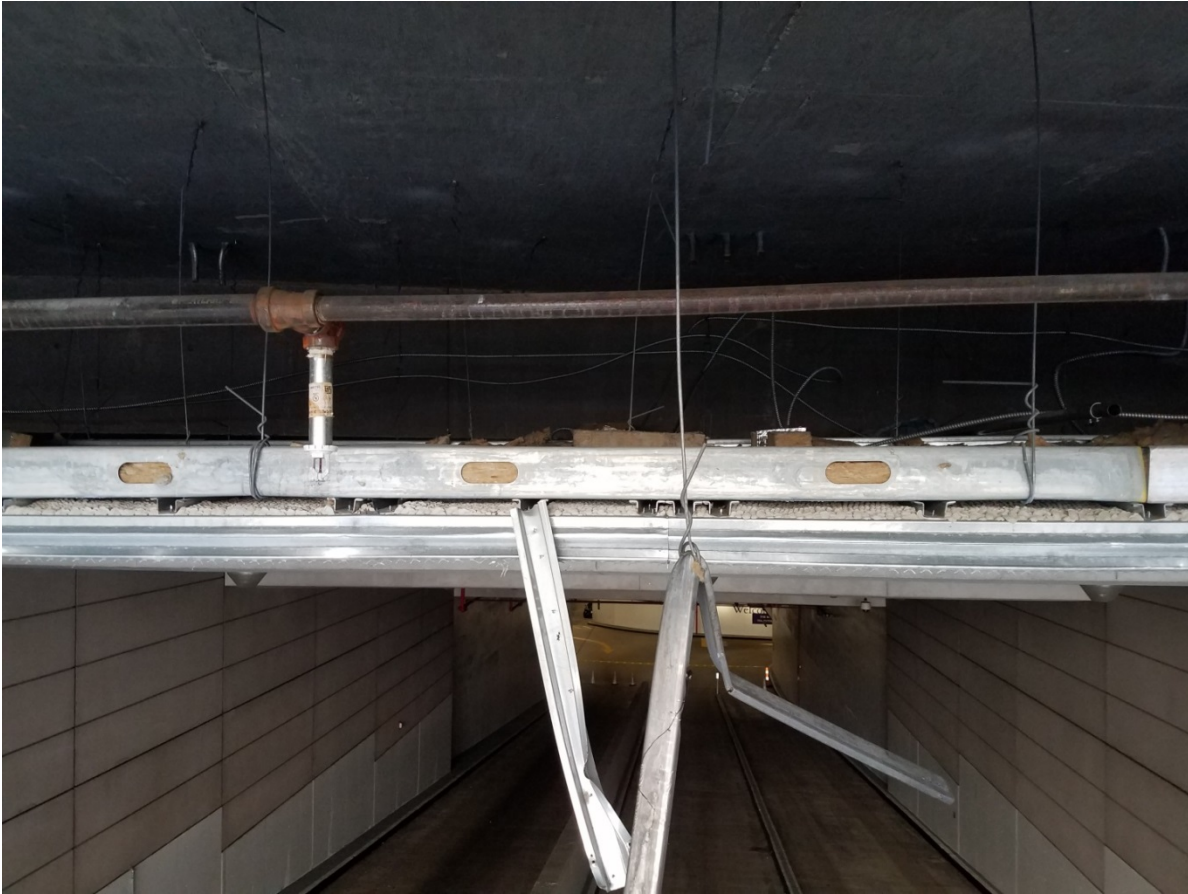
Picture 3: Typical existing framing – sagging ceiling at North Ramp

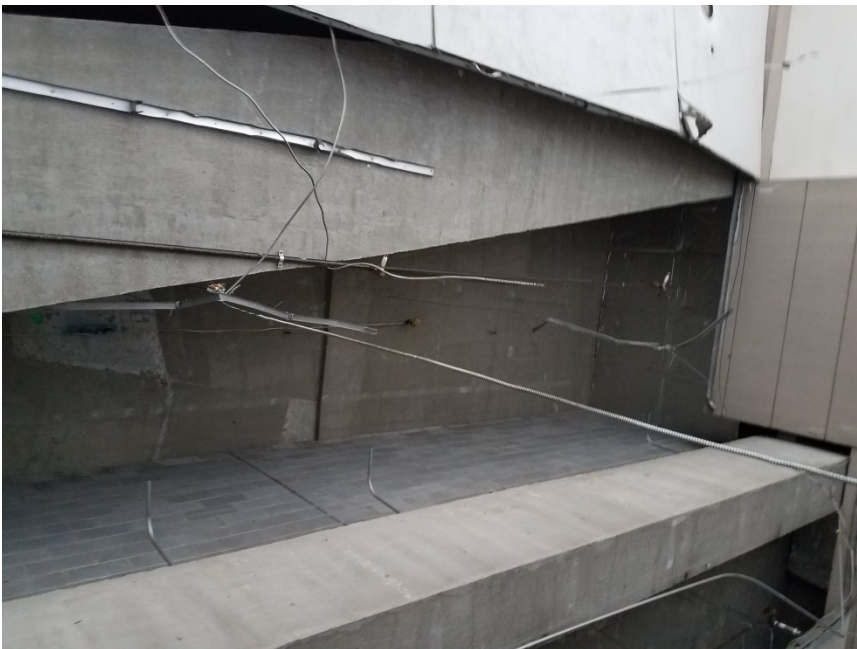
Picture 4: Typical existing framing – Ceiling at North Ramp

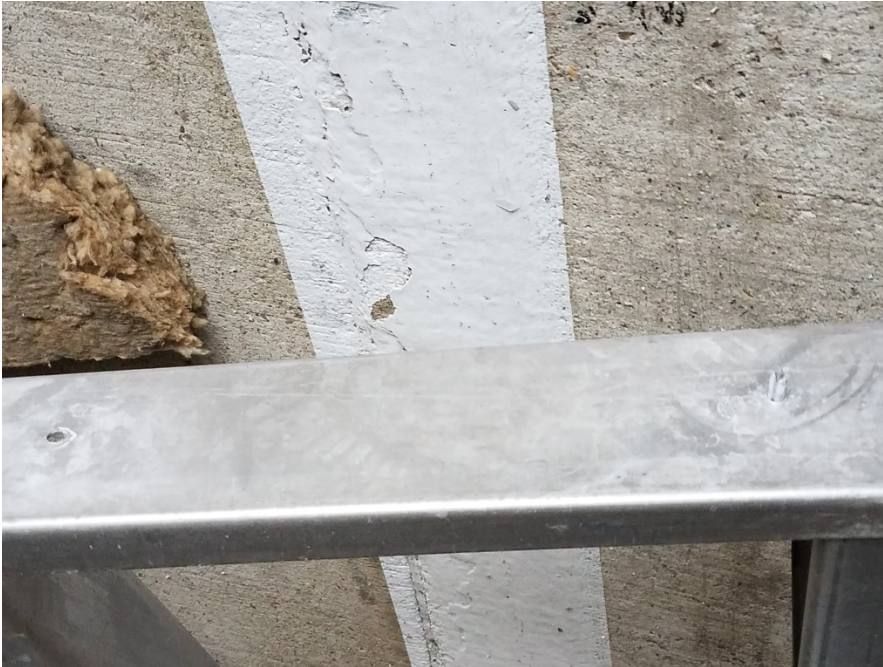
Picture 5: Typical existing framing – Ceiling track & fasteners

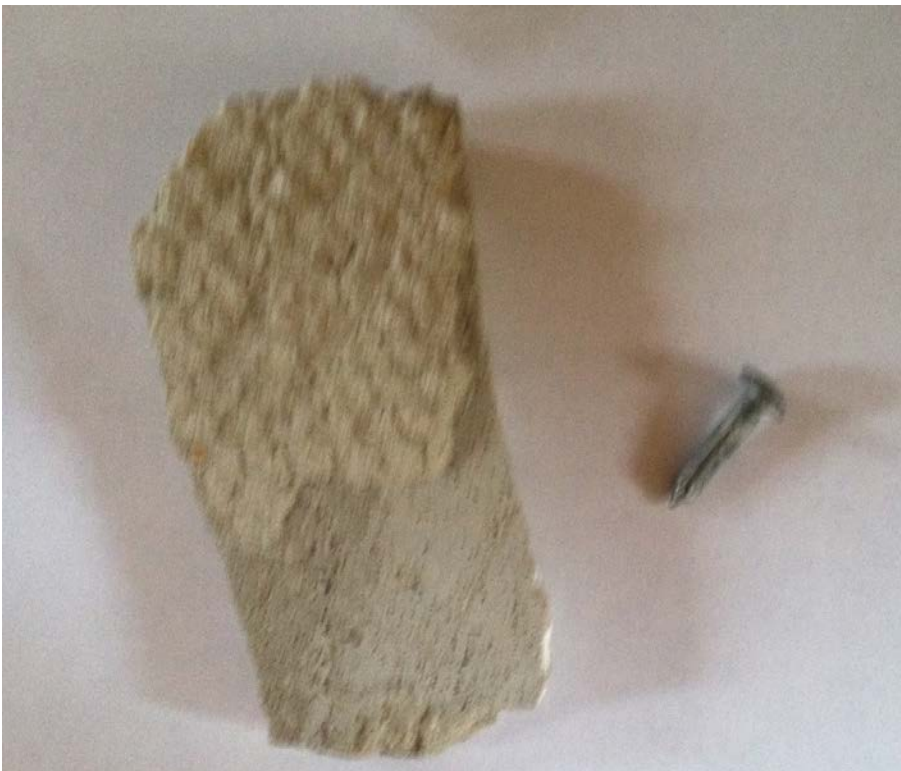
Picture 6: Typical existing framing – Ceiling Cement Plaster & Fastener

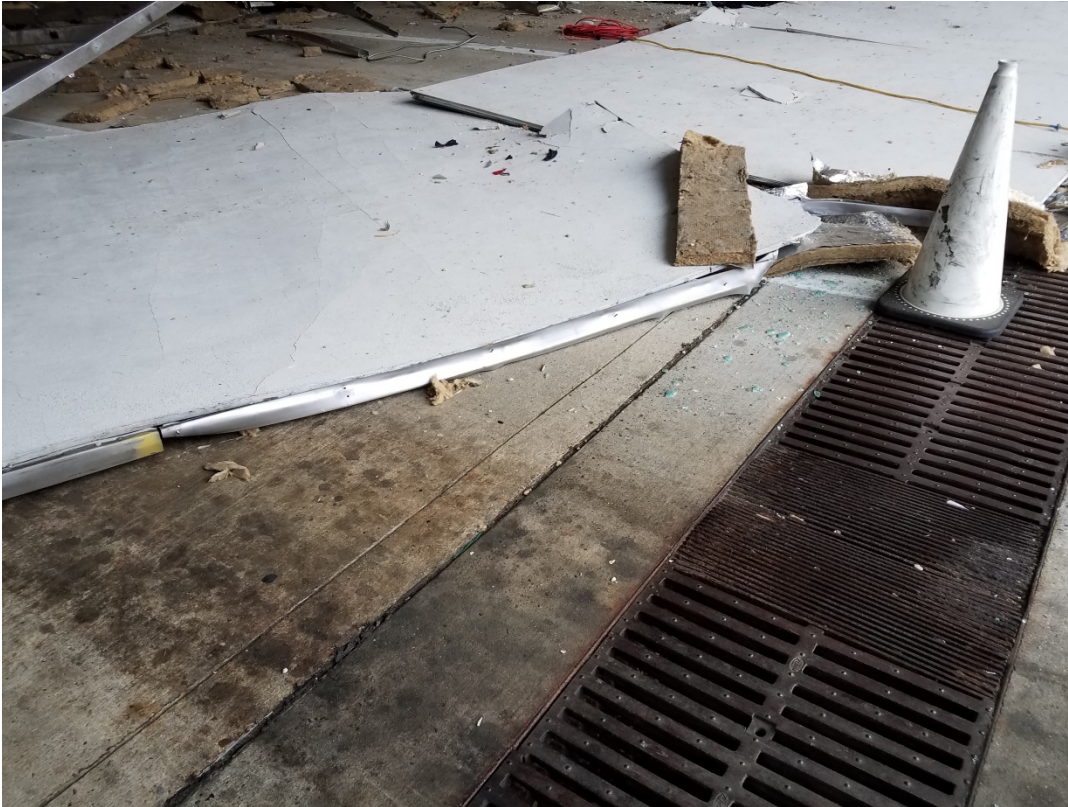
Picture 7: Typical existing framing – Cement Plaster Ceiling

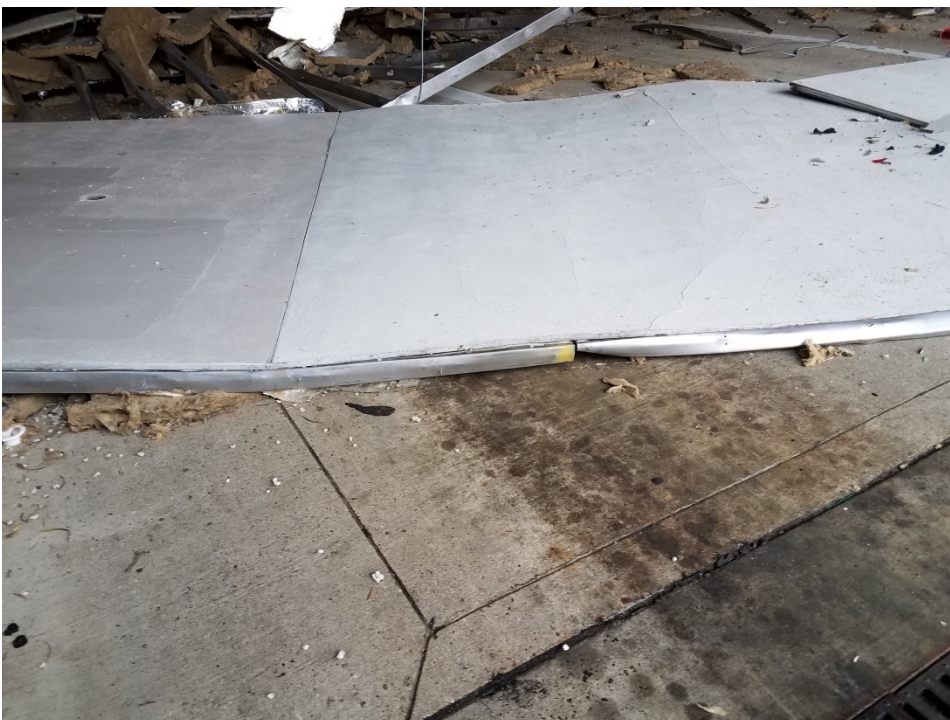
Picture 8: Typical existing framing – Cement Plaster Ceiling

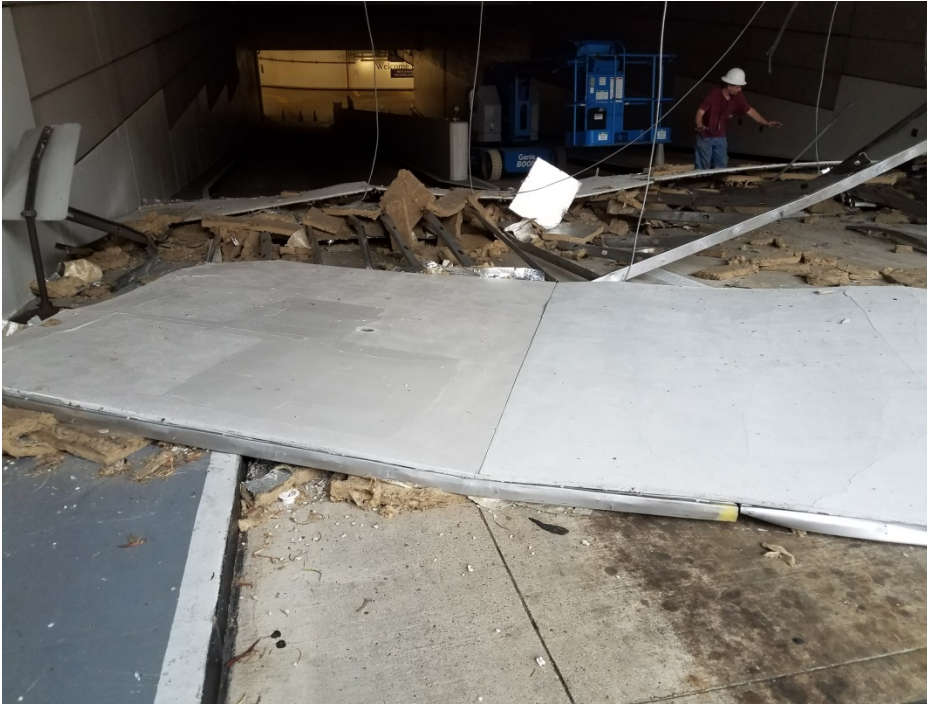
Picture 9: Typical existing framing – Cement Plaster Ceiling

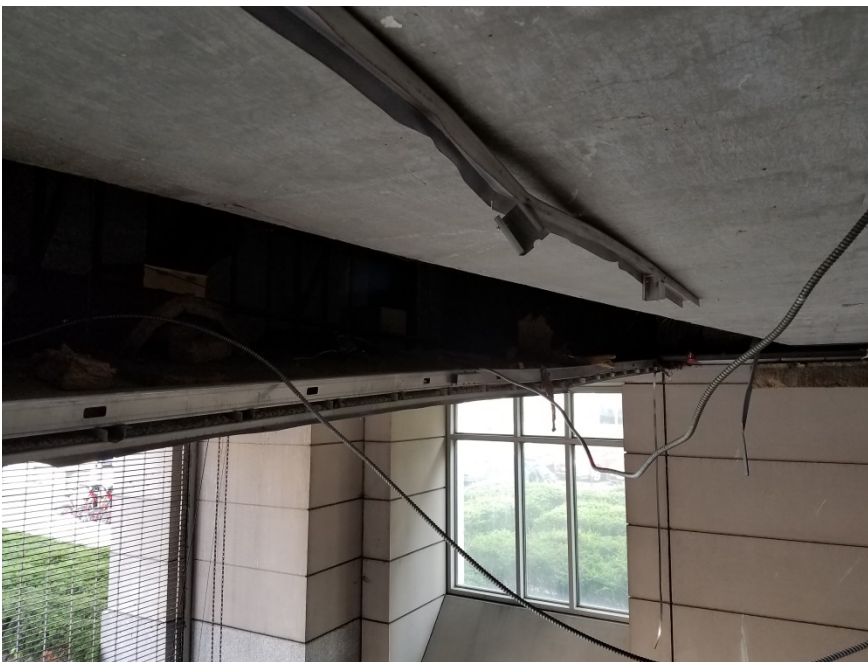
Picture 10: Typical existing framing –Ceiling hanger

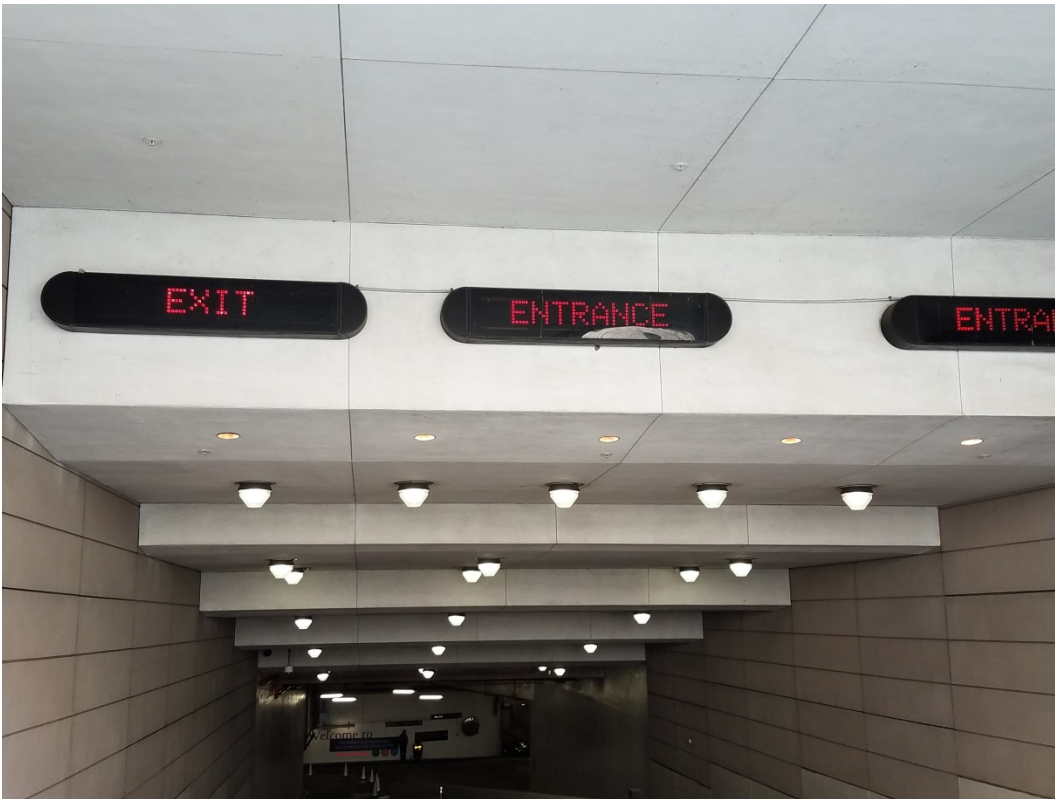
Picture 11: Typical existing Condition –North Ramp

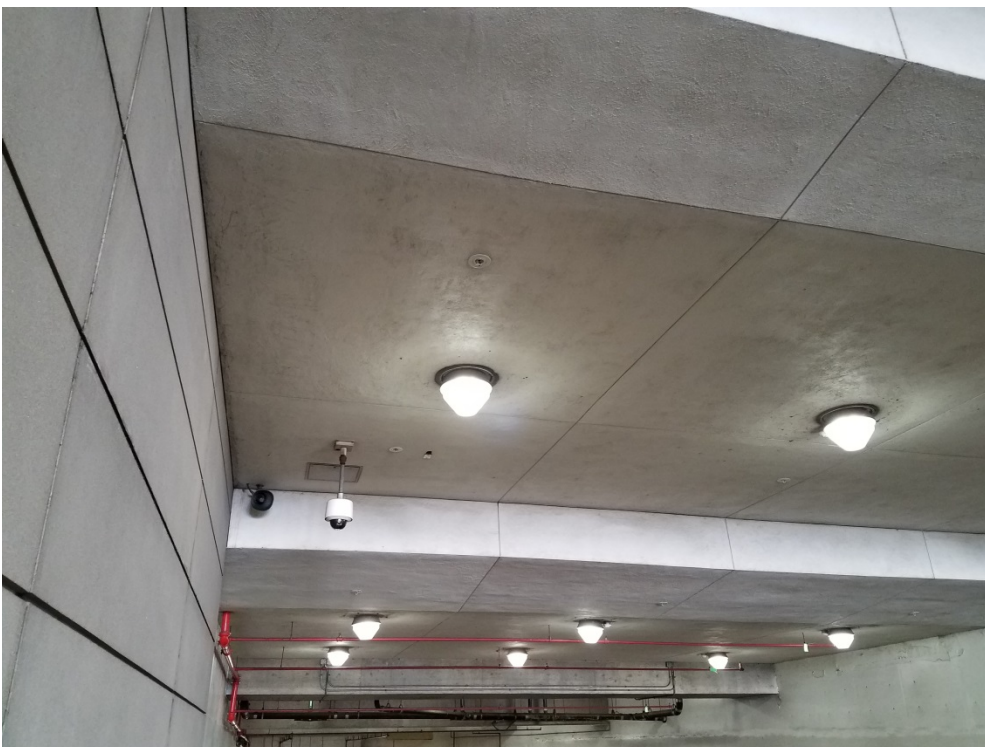
Picture 12: Typical existing Condition –North Ramp

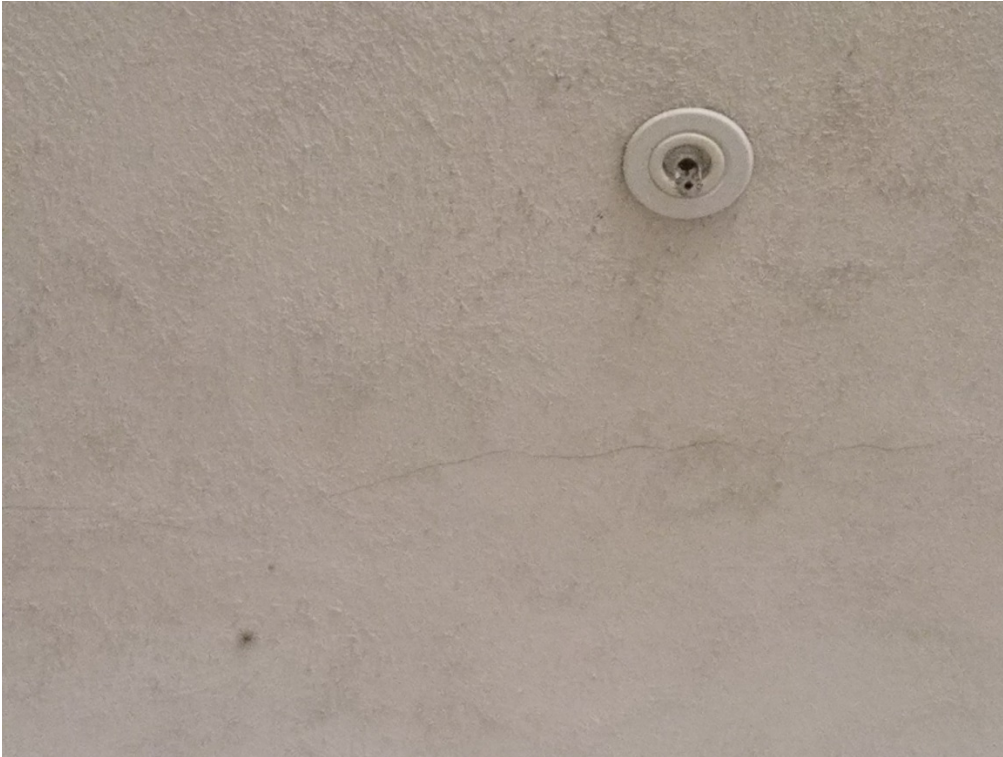
Picture 13: Typical existing Condition –North Ramp (cracked Ceiling – requires daily monitoring)

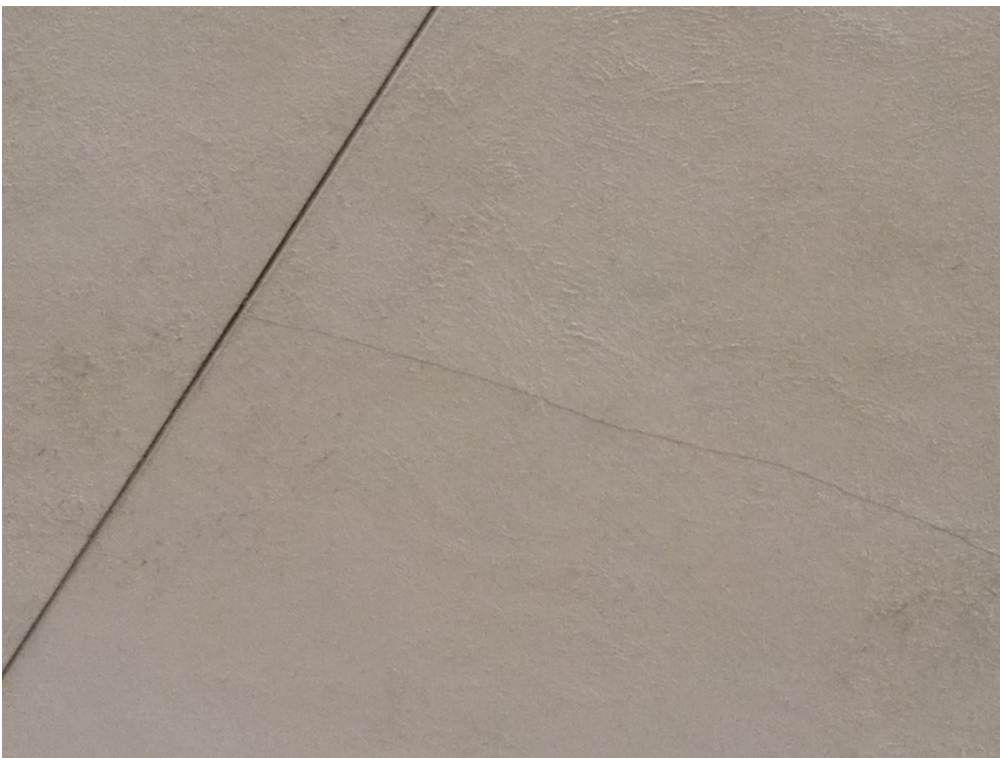
Picture 14: Typical existing Condition –North Ramp (cracked Ceiling – requires daily monitoring)

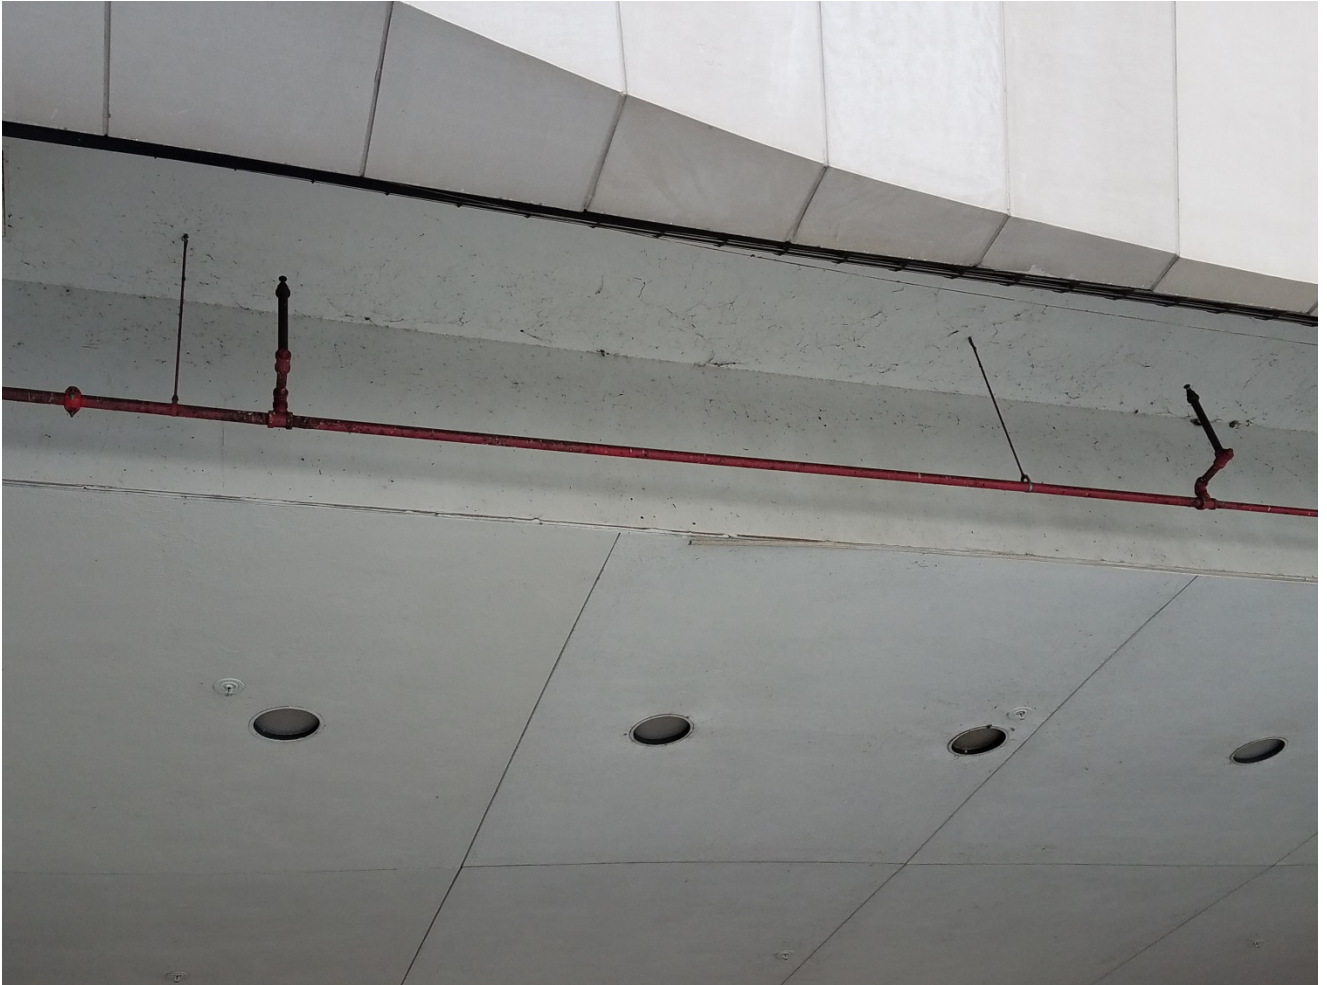
Picture 15: Typical existing Condition –North Ramp (peeling edge framing at end (requires monitoring))
